**Flood Control Project Maintenance
Levee Inspections****LMA District Cover Sheet****Spring 2014 Levee Inspection Results****Reclamation District No. 2091 Chase**

Spring 2014 Levee Inspection Results

Reclamation District No. 2091 Chase

Waterway			Bank	Unit Miles
Unit No. 01 San Joaquin River			Right	7.59
	Spring (March - May)	Summer (June - August)	(September - November) Fall	Winter (December - February)
Unit Maintenance Rating (Fall Only)				
Date of Inspection	04/15/2014 - 04/15/2014			
DWR Inspector	Richard Willoughby			
Accompanied By	Mike Alves RD 2091

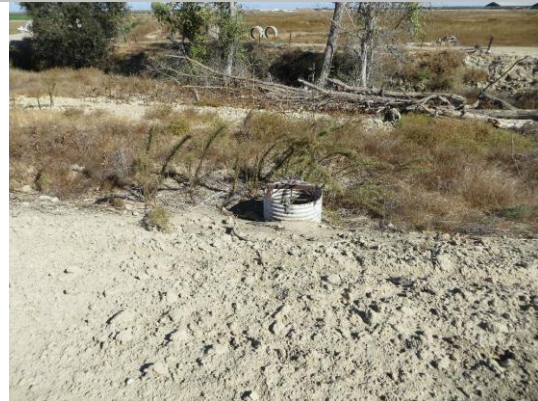
Photo 1 of 1 : UCIP_2988.jpg

LM Start	0.07	Rating **	M	Issue No.	6
LM End	0.07	Issue Type +	En	Location *	LS
Category	Supplemental			GPS Latitude/Longitude	
				Start	End
Item	DWR UCIP Field Study			37.541970 °	37.541970 °
				-121.093980 °	-121.093980 °
DWR ID	DWR_RD2091_01_s_2014_6				
Action/Comments					
Inspector Comments: FS_ID:22546					
EP_NO: N/A					
Repair Type:					
Crossing Status:					
UCIP Comments: Appears abandoned and if so should be done so properly.					
FIELD_STRUCT_DESC: 24-inch corrugated metal pipe through levee 7.2 feet below crown. Slide gate in 36-inch corrugated metal pipe riser on the waterward slope. Originally included in the 1961 O&M manual. As built drawings available, Drawing # 07-04-1555: 1555/17 & 1555/55, 906+85.					
FS Date: 10/15/2013 10:53:29 AM

Slide gate in 36-inch CMP riser on WS toe.

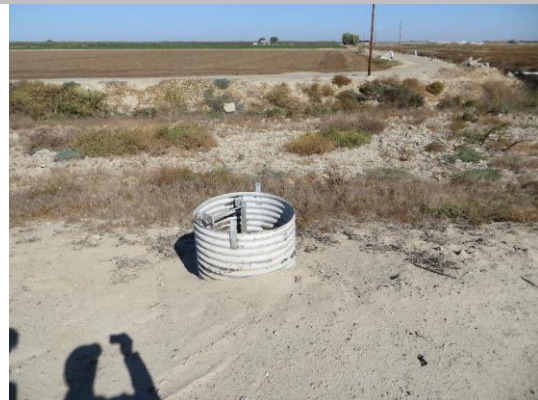
Photo 1 of 1 : UCIP_2990.jpg

LM Start	0.09	Rating **	M	Issue No.	7
LM End	0.09	Issue Type +	En	Location *	LS
Category	Supplemental			GPS Latitude/Longitude	
				Start	End
Item	DWR UCIP Field Study			37.542030 °	37.542030 °
				-121.094370 °	-121.094370 °
DWR ID	DWR_RD2091_01_s_2014_7				
Action/Comments					
Inspector Comments: FS_ID:22555					
EP_NO: N/A					
Repair Type:					
Crossing Status:					
UCIP Comments: Pipe open on WS and slide gate has been removed.					
Appears abandoned and should be done so properly.					
FIELD_STRUCT_DESC: 24-inch corrugated metal pipe through levee					
9.0 feet below crown. Slide gate in corrugated metal pipe riser on the					
waterward slope. Originally included in the 1961 O&M manual. As built					
drawings available, Drawing # 07-04-1555: 1555/17 & 1555/55, 907+55.					
FS Date: 10/15/2013

36-inch CMP riser on WS slope.

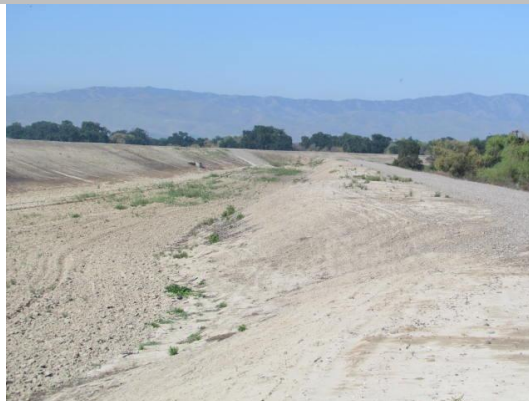
Photo 1 of 1 : richard_s_20140417_536.jpg

LM Start	0.10	Rating **	M	Issue No.	14
LM End	7.56	Issue Type +	Ma	Location *	LS
Category	Earthen Levee			GPS Latitude/Longitude	
				Start	End
Item	Vegetation			37.542012 °	37.479269 °
				-121.094524 °	-121.044715 °
DWR ID	DWR_RD2091_01_s _ 2014_14				
Action/Comments					
Control annual grass and weeds on the levee slopes and easements.

Looking south at typical view of landward slope.

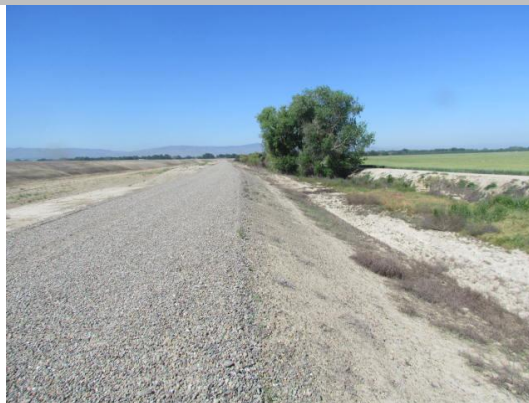
Photo 1 of 1 : richard_s_20140417_537.jpg

LM Start	0.10	Rating **	M	Issue No.	15
LM End	7.56	Issue Type +	Ma	Location *	WS
Category	Earthen Levee			GPS Latitude/Longitude	
				Start	End
Item	Vegetation			37.542010 °	37.479269 °
				-121.094526 °	-121.044714 °
DWR ID	DWR_RD2091_01_s _ 2014_15				
Action/Comments					
Control annual grass and weeds on the levee slopes and easements.

Looking south at typical view of waterward slope.

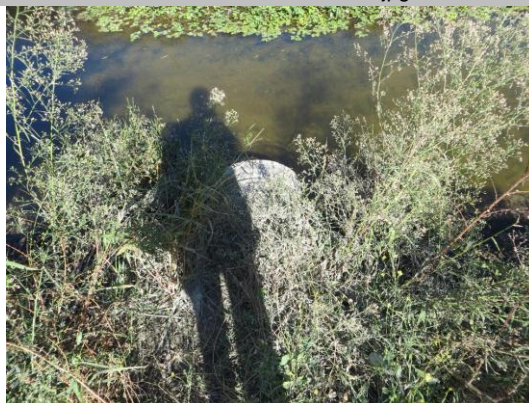
Photo 1 of 1 : UCIP_2993.jpg

LM Start	0.23	Rating **	M	Issue No.	9
LM End	0.23	Issue Type +	En	Location *	WS
Category	Supplemental			GPS Latitude/Longitude	
				Start	End
Item	DWR UCIP Field Study			37.541564 °	37.541564 °
				-121.096792 °	-121.096792 °
DWR ID	DWR_RD2091_01_s_2014_9				
Action/Comments					
Inspector Comments: FS_ID:22585					
EP_NO: N/A					
Repair Type:					
Crossing Status:					
UCIP Comments: Flap gate has fallen off at WS toe. Appears abandoned and if so should be done so properly.					
FIELD_STRUCT_DESC: 24-inch corrugated metal pipe through levee 10.0 feet below crown. Flap gate on the waterward end. Drain opening 15 feet off landward toe. Originally included in the 1961 O&M manual. As built drawings available, Drawing # 07-04-1555: 1555/17 & 1555/55, 915+00.					
FS Date: 10/15/2013

Pipe visible in canal on WS toe.

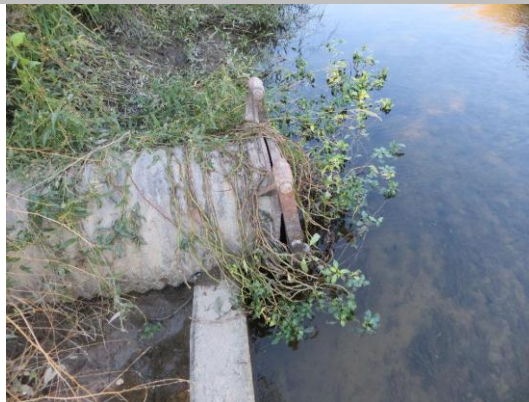
Photo 1 of 1 : UCIP_2994.jpg

LM Start	0.64	Rating **	M	Issue No.	10
LM End	0.64	Issue Type +	En	Location *	WS
Category	Supplemental			GPS Latitude/Longitude	
				Start	End
Item	DWR UCIP Field Study			37.541220 °	37.541220 °
				-121.103880 °	-121.103880 °
DWR ID	DWR_RD2091_01_s_2014_10				
Action/Comments					
Inspector Comments: FS_ID:22601					
EP_NO: N/A					
Repair Type:					
Crossing Status:					
UCIP Comments: Appears abandoned and if so should be done so properly.					
FIELD_STRUCT_DESC: 24-inch corrugated metal pipe through levee 12.0 feet below crown. Flap gate on the waterward end. Concrete headwall on WS toe. Originally included in the 1961 O&M manual.					
FS Date: 10/15/2013

24-inch CMP on concrete headwall with flapgate on WS toe.

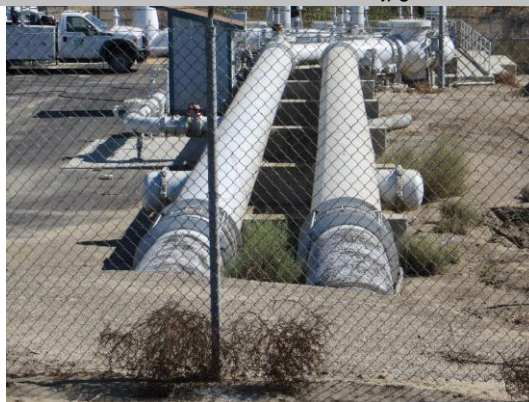
Photo 1 of 1 : UCIP_3002.jpg

LM Start	2.44	Rating **	M	Issue No.	11
LM End	2.44	Issue Type +	En	Location *	LS
Category	Supplemental			GPS Latitude/Longitude	
				Start	End
Item	DWR UCIP Field Study			37.522130 °	37.522130 °
				-121.095630 °	-121.095630 °
DWR ID	DWR_RD2091_01_s _ 2014_11				
Action/Comments					
Inspector Comments: FS_ID:22634					
EP_NO: 5560					
Repair Type:					
Crossing Status:					
UCIP Comments: Siphon breaker missing parts and pipe open at 24-inch riser on WS shoulder.					
FIELD_STRUCT_DESC: 2 of 3: 36-inch pipe through levee 3.0-feet below crown. Siphon breaker in 24-inch CMP riser on the waterward shoulder. Butterfly valve next to pump off LS toe. Concrete "U"-shaped headwall off the WS toe (Permit No 5560, 1969). Check about missing parts					
FS Date: 10/15/2013

Pipe, pump, and butterfly valve off LS toe.

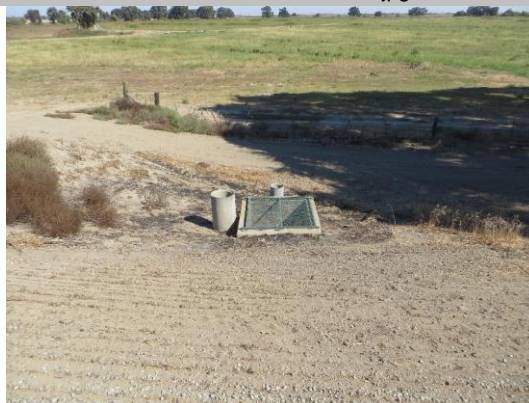
Photo 1 of 1 : UCIP_3013.jpg

LM Start	4.67	Rating **	M	Issue No.	13
LM End	4.67	Issue Type +	En	Location *	LS
Category	Supplemental			GPS Latitude/Longitude	
				Start	End
Item	DWR UCIP Field Study			37.497390 °	37.497390 °
				-121.080370 °	-121.080370 °
DWR ID	DWR_RD2091_01_s _ 2014_13				
Action/Comments					
Inspector Comments: FS_ID:22639					
EP_NO: N/A					
Repair Type:					
Crossing Status:					
UCIP Comments: Appears abandoned and if so should be done so properly.					
FIELD_STRUCT_DESC: 36-inch corrugated metal pipe through levee 15.0 feet below crown. Abandoned concrete inlet box on the waterward slope of levee. 6'X5' Concrete distribution box at the landward toe. Originally included in the 1961 O&M manual.					
FS Date: 10/15/2013

Distribution box on LS toe.

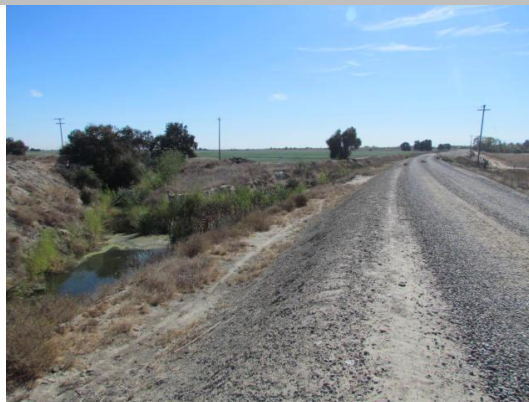
Photo 1 of 2 : richard_s_20140320_433.jpg

LM Start	7.55	Rating **	U	Issue No.	8
LM End	7.55	Issue Type +	En	Location *	LS
Category	Earthen Levee			GPS Latitude/Longitude	
				Start	End
Item	Encroachments				o
					o
DWR ID	DWR_RD2091_01_f _ 2013_8				
Action/Comments					
Ditch					
Inspector Comments: Ditch has been in place for several years. Ditch is 10' to 15' from the landward toe and is 15" to 20' deep.

Looking southeast at drainage ditch at landward toe.

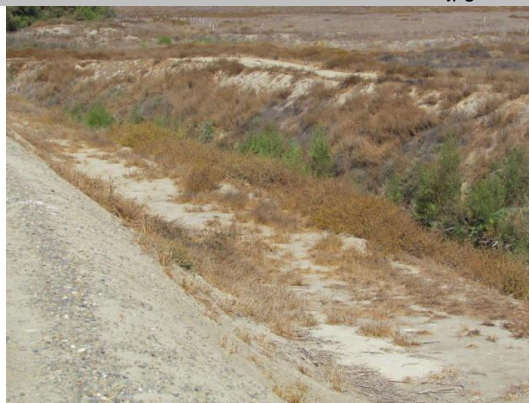
Photo 2 of 2 : richard_s_20140320_434.jpg

LM Start	7.55	Rating **	U	Issue No.	8 (cont)	
LM End	7.55	Issue Type +	En	Location *	LS	
Category	Earthen Levee			GPS Latitude/Longitude		
				Start		End
Item	Encroachments				°	°
					°	
DWR ID	DWR_RD2091_01_f_2013_8					
Action/Comments						
Ditch						
Inspector Comments: Ditch has been in place for several years. Ditch is 10' to 15' from the landward toe and is 15" to 20' deep.

Looking east at drainage ditch at landward toe.

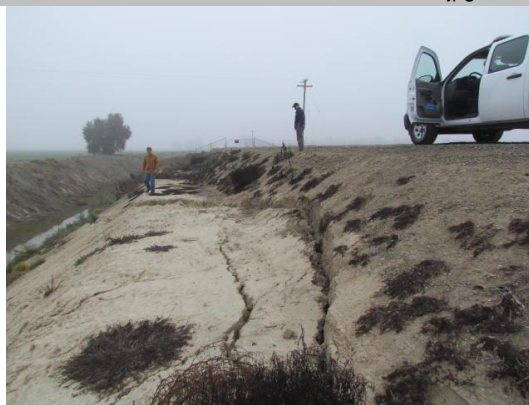
Photo 1 of 8 : richard_s_20140320_425.jpg

LM Start	7.55	Rating **	A/W	Issue No.	3
LM End	7.55	Issue Type +	Ma	Location *	LS
Category	Earthen Levee			GPS Latitude/Longitude	
				Start	End
Item	Slope Stability			37.479203 °	37.479203 °
				-121.044695 °	-121.044695 °
DWR ID	DWR_RD2091_01_s_2012_3				
Action/Comments					
Repair slope instability. Inspector Comments: Slide appears to be 100' + feet long on landside slope. Cracks are approx. 4-9" wide and 12-18" deep. Slide extends from the middle of the landside slope to landside toe. District indicated that the landowner repaired erosion/slip with no supervisor from LMA or State. No compaction results was provided. Site does appear to be stable at time of inspection, but should be monitored by LMA.

Looking south at slide on landside slope next to irrigation ditch.

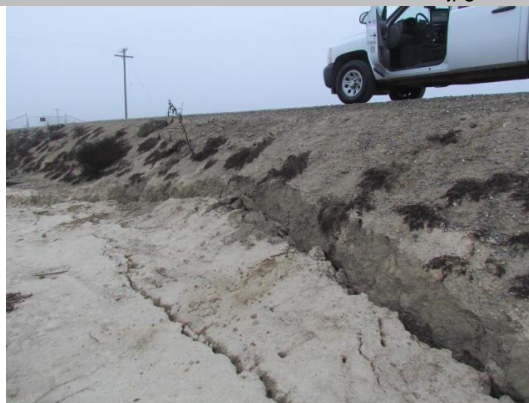
Photo 2 of 8 : richard_s_20140320_426.jpg

LM Start	7.55	Rating **	A/W	Issue No.	3 (cont)
LM End	7.55	Issue Type +	Ma	Location *	LS
Category	Earthen Levee			GPS Latitude/Longitude	
				Start	End
Item	Slope Stability			37.479203 °	37.479203 °
				-121.044695 °	-121.044695 °
DWR ID	DWR_RD2091_01_s _ 2012_3				
Action/Comments					
Repair slope instability. Inspector Comments: Slide appears to be 100' + feet long on landside slope. Cracks are approx. 4-9" wide and 12-18" deep. Slide extends from the middle of the landside slope to landside toe. District indicated that the landowner repaired erosion/slip with no supervisor from LMA or State. No compaction results was provided. Site does appear to be stable at time of inspection, but should be monitored by LMA.

Looking southwest a slide on landside slope.

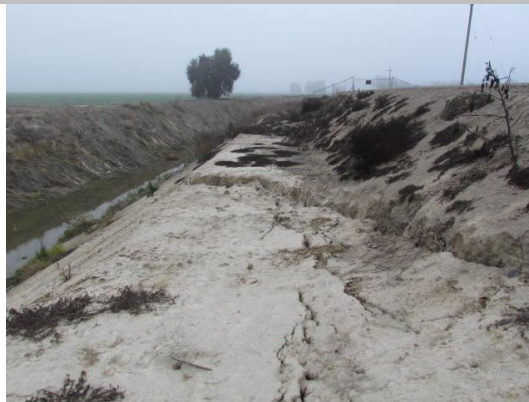
Photo 3 of 8 : richard_s_20140320_427.jpg

Looking at south end of slide.

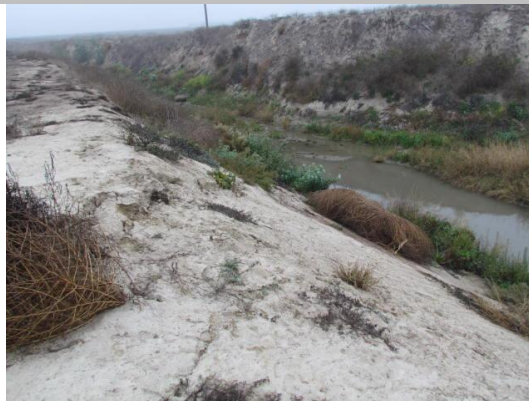
Photo 4 of 8 : richard_s_20140320_428.jpg

Looking at north end of slide next to irrigation ditch.

LM Start	7.55	Rating **	A/W	Issue No.	3 (cont)	
LM End	7.55	Issue Type +	Ma	Location *	LS	
Category	Earthen Levee			GPS Latitude/Longitude		
				Start		End
Item	Slope Stability			37.479203 °	37.479203 °	
				-121.044695 °	-121.044695 °	
DWR ID	DWR_RD2091_01_s _ 2012_3					
Action/Comments						
Repair slope instability.

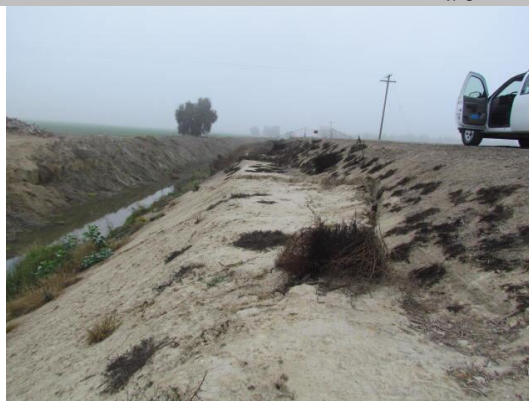
Photo 5 of 8 : richard_s_20140320_429.jpg

Looking south at irrigation ditch at landside toe.

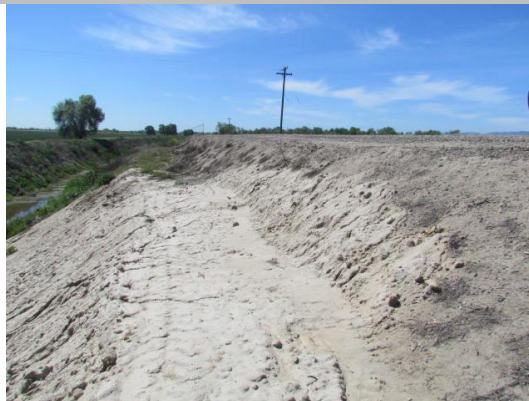
Photo 6 of 8 : richard_s_20140320_430.jpg

Looking south at repaired erosion/slip on landside slope.

LM Start	7.55	Rating **	A/W	Issue No.	3 (cont)
LM End	7.55	Issue Type +	Ma	Location *	LS
Category	Earthen Levee			GPS Latitude/Longitude	
				Start	End
Item	Slope Stability			37.479203 °	37.479203 °
				-121.044695 °	-121.044695 °
DWR ID	DWR_RD2091_01_s _ 2012_3				
Action/Comments					
Repair slope instability.

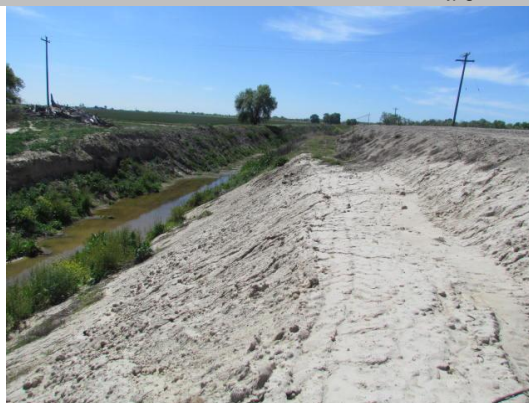
Photo 7 of 8 : richard_s_20140320_431.jpg

Looking southeast at repaired erosion/slip on landside slope next to irrigation canal.

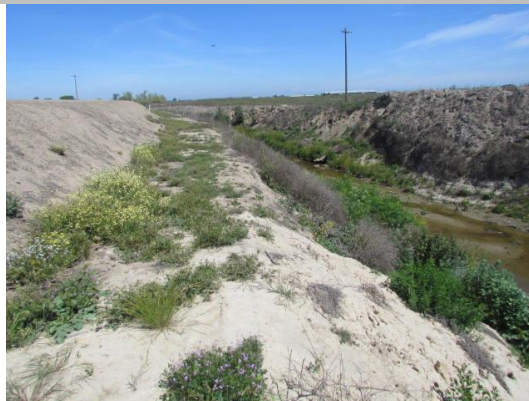
Photo 8 of 8 : richard_s_20140320_432.jpg

Looking north at repaired erosion/slip on landside slope next to irrigation canal.

LM Start	7.55	Rating **	A/W	Issue No.	3 (cont)
LM End	7.55	Issue Type +	Ma	Location *	LS
Category	Earthen Levee			GPS Latitude/Longitude	
				Start	End
Item	Slope Stability			37.479203 °	37.479203 °
				-121.044695 °	-121.044695 °
DWR ID	DWR_RD2091_01_s _ 2012_3				
Action/Comments					
Repair slope instability.

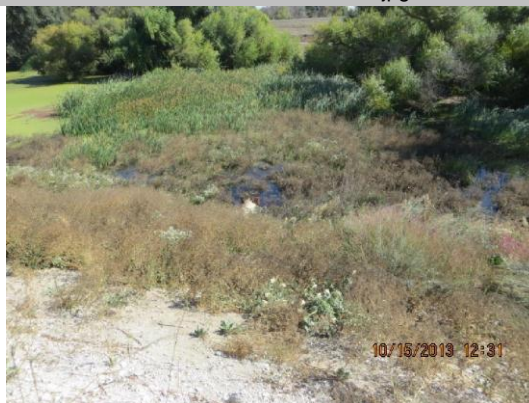
Photo 1 of 1 : UCIP_3015.jpg

LM Start	0.02	Rating **	M	Issue No.	9
LM End	0.02	Issue Type +	En	Location *	LS
Category	Supplemental			GPS Latitude/Longitude	
				Start	End
Item	DWR UCIP Field Study			37.482450 °	37.482450 °
				-121.051220 °	-121.051220 °
DWR ID	DWR_RD2091_02_s_2014_9				
Action/Comments					
Inspector Comments: FS_ID:22641					
EP_NO: N/A					
Repair Type:					
Crossing Status:					
UCIP Comments: Flap gate rusted in-place and does not function. In closed position.					
FIELD_STRUCT_DESC: 24-inch corrugated metal drain pipe through levee 16.4-feet below the crown. Flap gate on the waterward toe.					
FS Date: 10/15/2013

24-inch CMP with flapgate visible on WS toe.

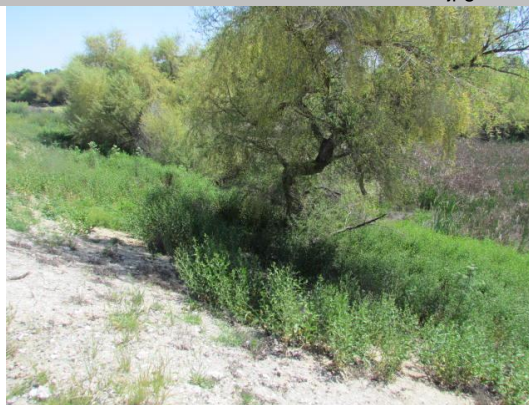
Photo 1 of 1 : richard_s_20140417_539.jpg

LM Start	0.03	Rating **	A/W	Issue No.	1
LM End	0.03	Issue Type +	Ma	Location *	WS
Category	Earthen Levee			GPS Latitude/Longitude	
				Start	End
Item	Trim / Thin Trees			37.482523 °	37.482523 °
				-121.051103 °	-121.051103 °
DWR ID	DWR_RD2091_02_s_2012_1				
Action/Comments					
Thin trees to allow visibility of the ground and room to flood fight.

Looking east at untrimmed tree on waterward slope.

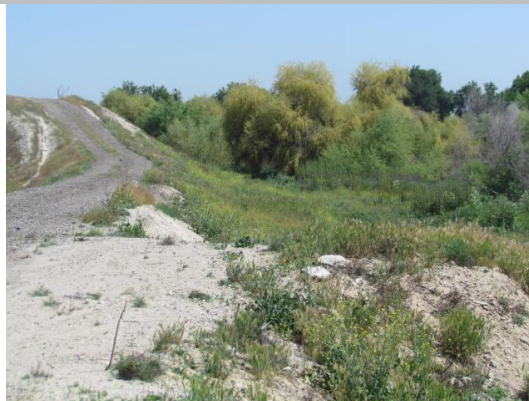
Photo 1 of 1 : richard_s_20140417_538.jpg

LM Start	0.06	Rating **	M	Issue No.	2
LM End	0.10	Issue Type +	Ma	Location *	LS
Category	Earthen Levee			GPS Latitude/Longitude	
				Start	End
Item	Vegetation			37.482815 °	37.483306 °
				-121.050849 °	-121.050302 °
DWR ID	DWR_RD2091_02_f_2012_2				
Action/Comments					
Remove the wild growth other than native grasses from the levee slopes.

Looking east at vegetation on waterward slope.

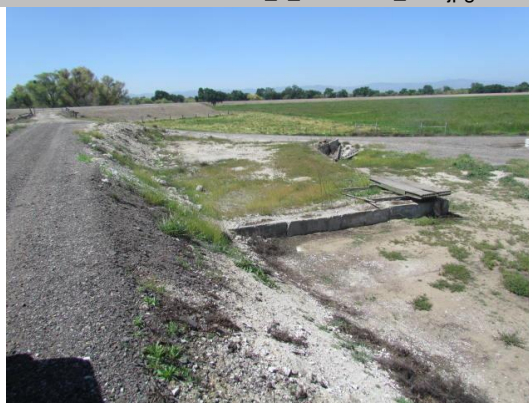
Photo 1 of 1 : richard_s_20140417_540.jpg

LM Start	0.06	Rating **	M	Issue No.	12
LM End	0.06	Issue Type +	En	Location *	LS
Category	Earthen Levee			GPS Latitude/Longitude	
				Start	End
Item	Encroachments			37.482844 °	37.482844 °
				-121.050816 °	-121.050816 °
DWR ID	DWR_RD2091_02_s_2014_12				
Action/Comments					
Retaining Wall					
Inspector Comments: Abandoned concrete foundation on landward toe.

Looking west at concrete foundation/retaining wall at landward toe.

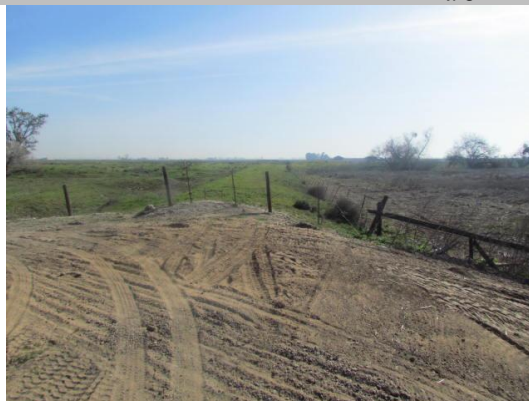
Photo 1 of 1 : richard_s_20140320_446.jpg

LM Start	0.18	Rating **	M	Issue No.	3
LM End	0.18	Issue Type +	Ma	Location *	WS
Category	Earthen Levee			GPS Latitude/Longitude	
				Start	End
Item	Trim / Thin Trees			37.484342 °	37.484342 °
				-121.049848 °	-121.049848 °
DWR ID	DWR_RD2091_02_f_2012_3				
Action/Comments					
Trim trees to at least five feet above ground level.

Looking southeast at the end of the project levee.

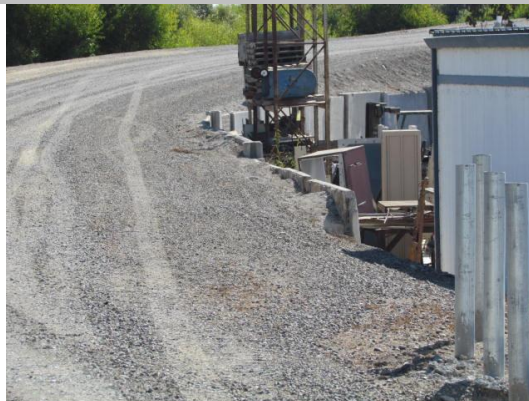
Photo 1 of 2 : richard_s_20140320_449.jpg

LM Start	0.20	Rating **	M	Issue No.	6		
LM End	0.20	Issue Type +	En	Location *	LS		
Category	Earthen Levee			GPS Latitude/Longitude			
				Start		End	
Item	Encroachments				°		°
					°		°
DWR ID	DWR_RD2091_02_f_2013_6						
Action/Comments							
Retaining Wall							
Inspector Comments: Retaining walls has been in place for several years.

Looking east at retaining walls on landward toe.

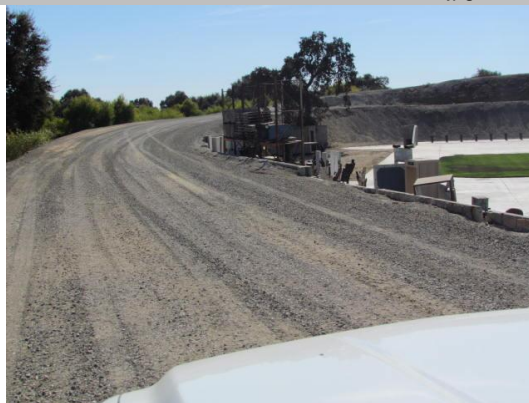
Photo 2 of 2 : richard_s_20140320_450.jpg

Looking northeast at retaining walls within the City of Modesto shooting range on landward slope and toe.

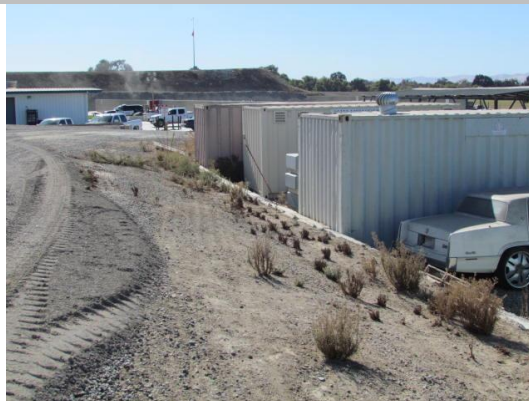
Photo 1 of 1 : richard_s_20140320_452.jpg

LM Start	0.22	Rating **	M	Issue No.	8
LM End	0.22	Issue Type +	En	Location *	LS
Category	Earthen Levee			GPS Latitude/Longitude	
				Start	End
Item	Encroachments				°
					°
DWR ID	DWR_RD2091_02_f_2013_8				
Action/Comments					
Equipment

Looking northeast at storage containers and abandoned vehicle at landward toe.

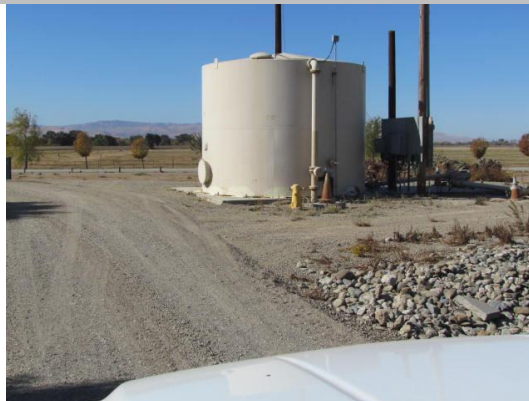
Photo 1 of 1 : richard_s_20140320_451.jpg

LM Start	0.25	Rating **	M	Issue No.	7
LM End	0.25	Issue Type +	En	Location *	LS
Category	Earthen Levee			GPS Latitude/Longitude	
				Start	End
Item	Encroachments				°
					°
DWR ID	DWR_RD2091_02_f_2013_7				
Action/Comments					
Tank					
Inspector Comments: Water tank has been in place for several years.

Looking west at water tank on landward shoulder.

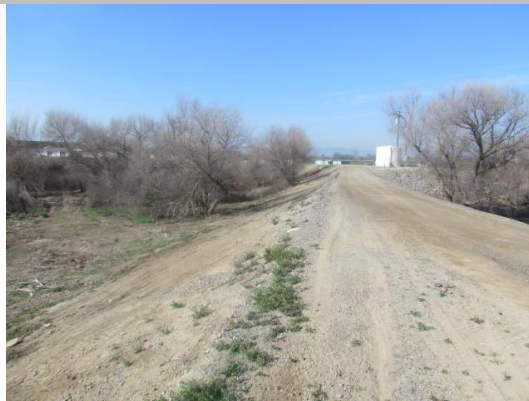
Photo 1 of 1 : richard_s_20140320_447.jpg

LM Start	0.29	Rating **	M	Issue No.	4
LM End	0.29	Issue Type +	Ma	Location *	LS
Category	Earthen Levee			GPS Latitude/Longitude	
				Start	End
Item	Trim / Thin Trees			37.485447 °	37.485447 °
				-121.049750 °	-121.049750 °
DWR ID	DWR_RD2091_02_f_2012_4				
Action/Comments					
Trim trees to at least five feet above ground level.

Looking east at trimmed trees on landside slope and toe.
